BLM Cedar City Field Office Site Inspection Report

January 8, 2002

To: Case file UTU-72232, 43 CFR 3809 POO
Gemstone Mining Inc., Red Emerald Mine

Subject: Site Inspection

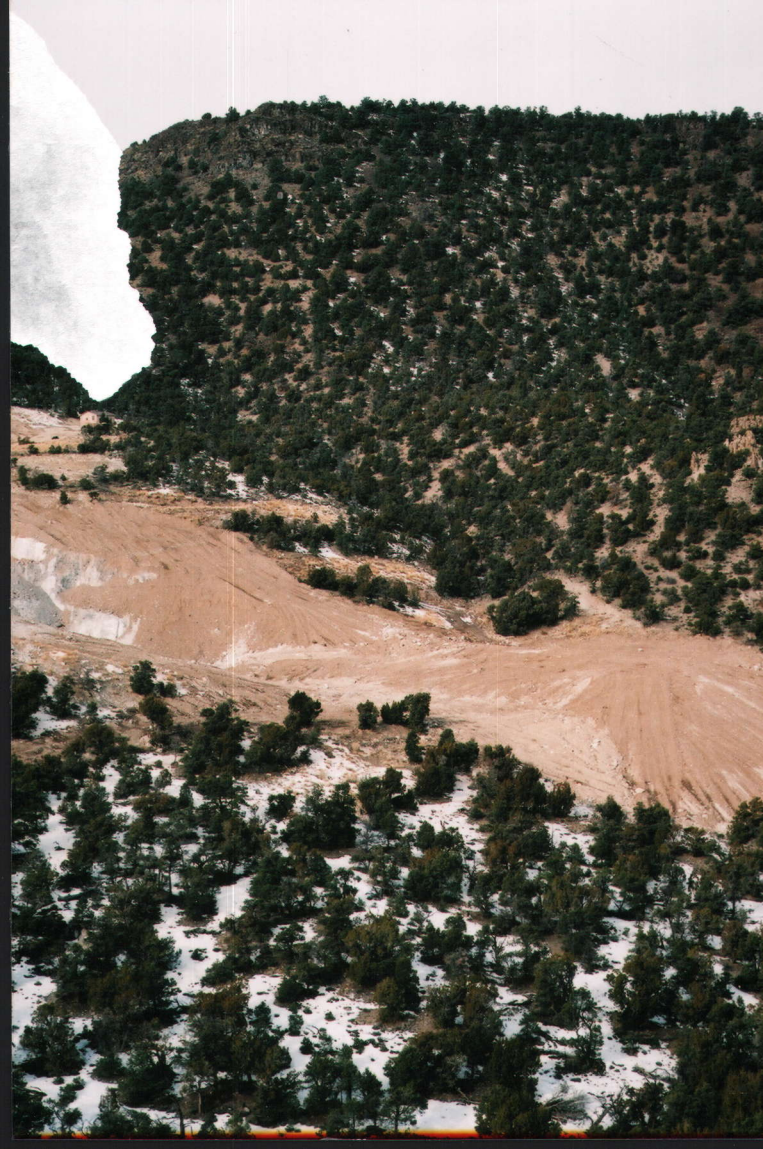
(No. 2)

Photo 2: View of reclaimed lower (Harris) pit area looking southwest from edge of reclaimed lower pit waste dump. Photo taken January 8, 2002 by Ed Ginouves.

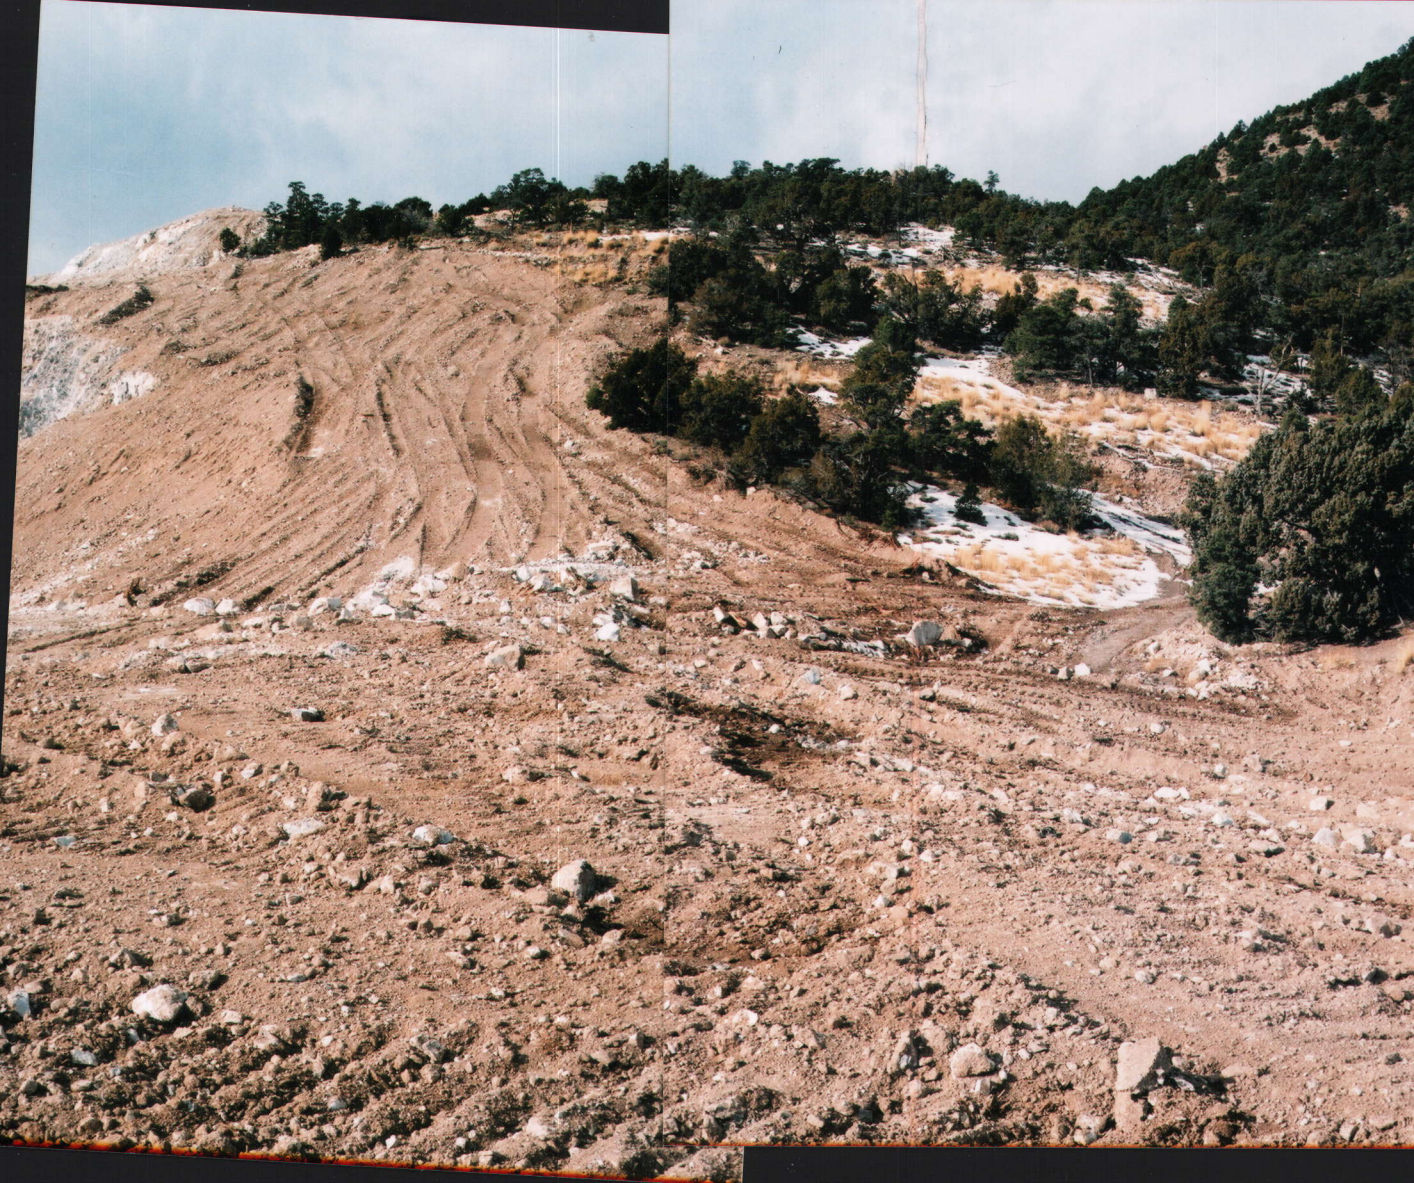
<No. 4>

Photo 4: View of reclaimed upper pit and waste dump area, and upper portal area, looking southwest from remaining mine road. Photo taken January 8, 2002 by Ed Ginouves.

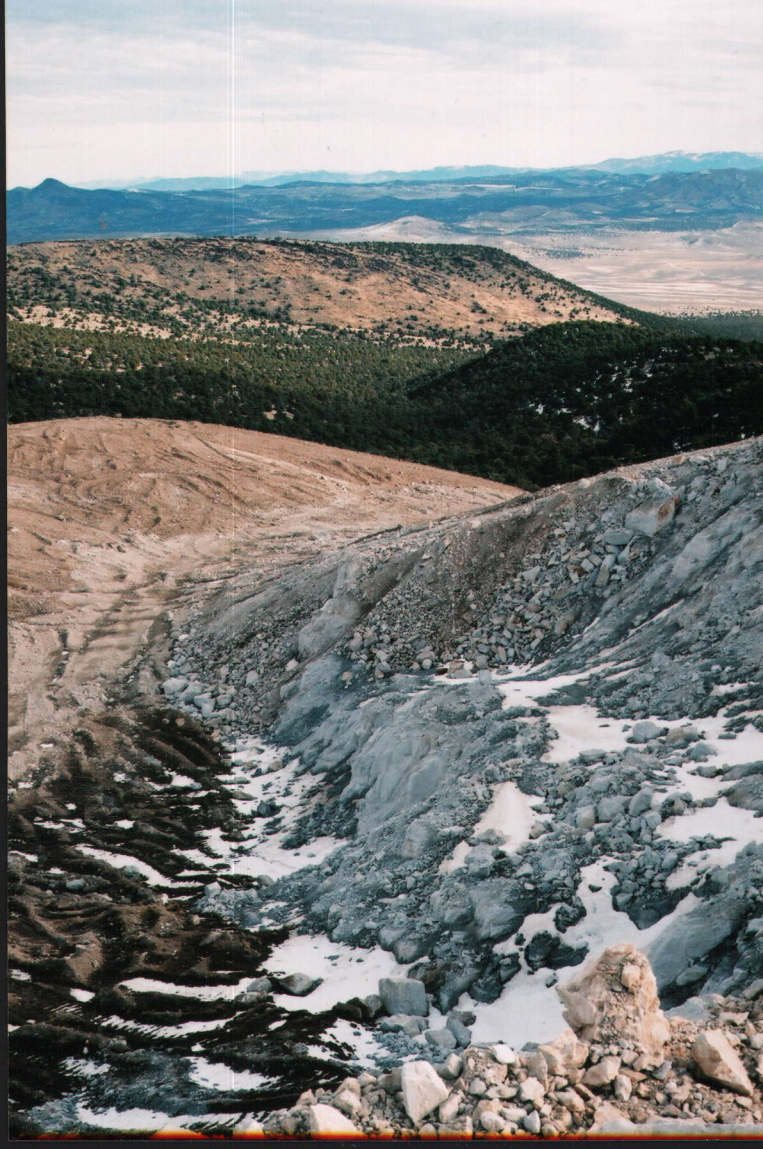
Photo 5: View of reclaimed GMI waste dump area, and lower portal bench area looking south from remaining mine road. Photo taken January 8, 2002 by Ed Ginouves.
